ASBESTOS SURVEY FOR FORT POINT U.S. COAST GUARD STATION

Volume II

Presidio of San Francisco

The Presidio of San Francisco
Phase II Environmental Study

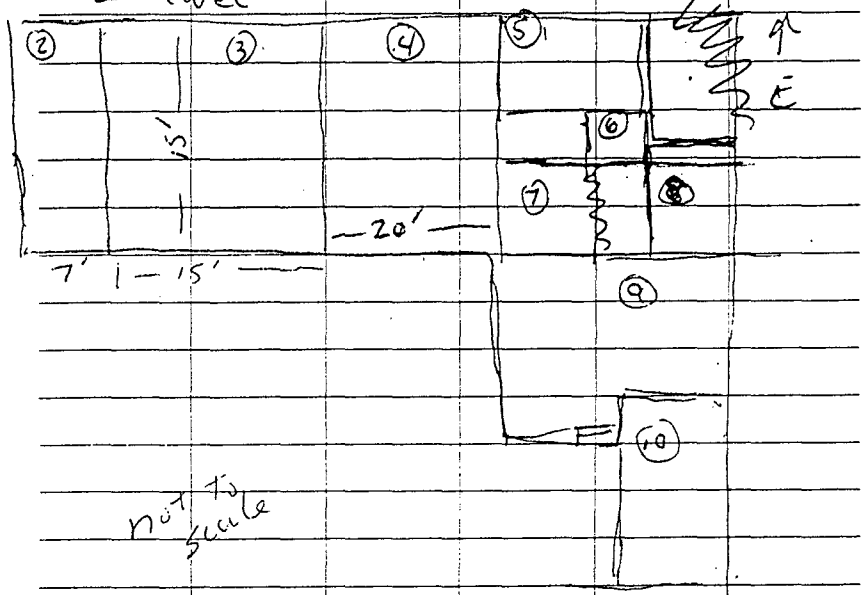
1st level - enclosed porch - east side of Bldg

- linoleum floor
- baseboard material (flexible

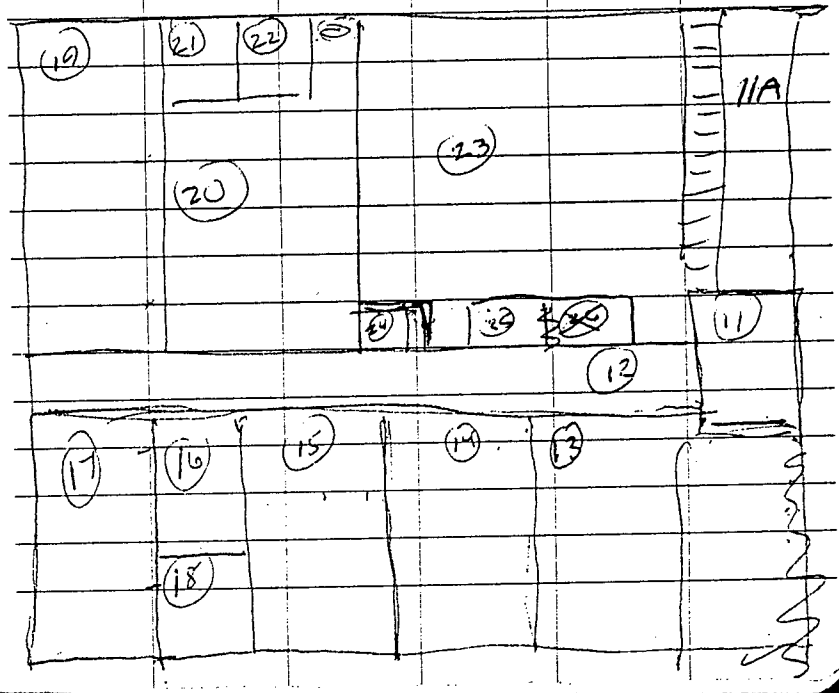
LEVEL 3

Room (9) main entry way
- ceiling tile ✓ (A, B)
- stairs ✓

Room (10) front office
- 12" ceiling tile ✓
- linoleum on steps ✓

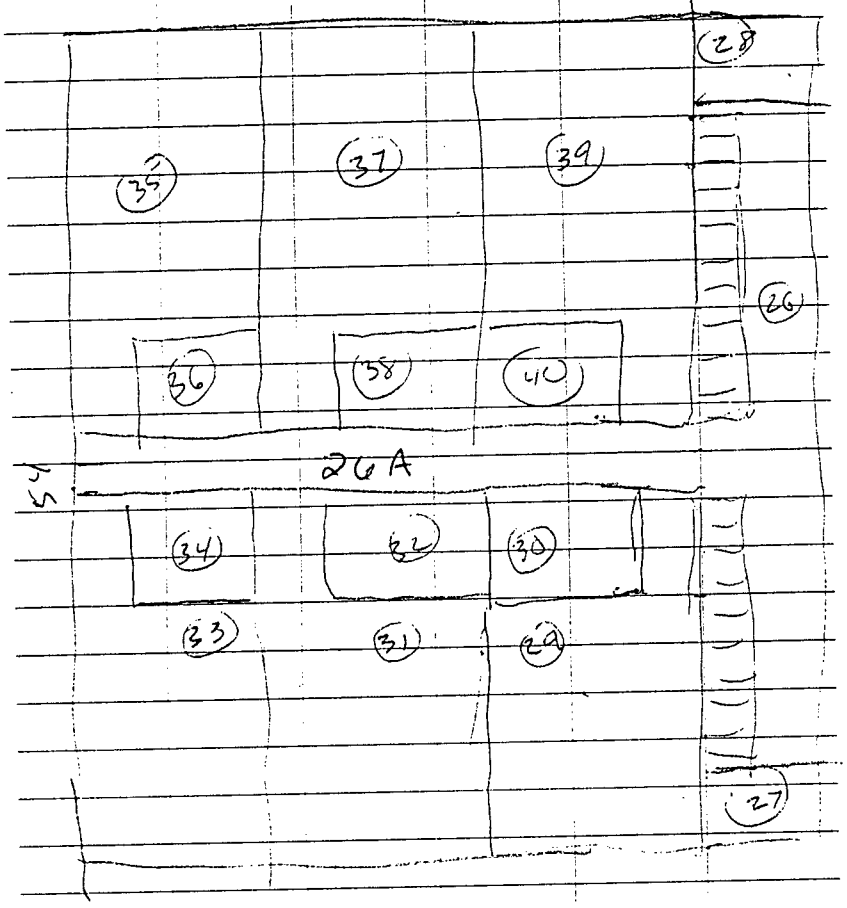
LEVEL 4

(27) An handling room
- insulated ductwork
- pipe insulation
- 12" floor tile
- flex. baseboard

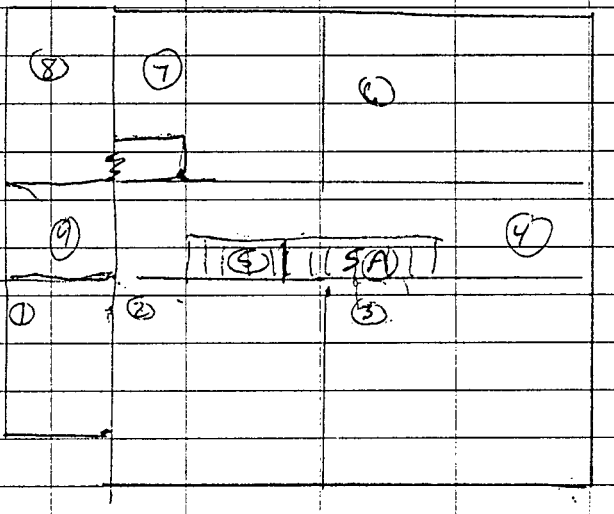
11-
Ø28 wga 11/6/90 wga
Bldg ~~48~~ 992
- Basement & insulating matl
- duct wrap (3 types)
~~wrap~~ - pink - non-coated (fiberglass)
10" & 14" diam - yellow - coated w/ gray plastic
- yellow w/ black asphalt backing
- sheetrock - ceiling & upper 2' of E, W, & N walls.

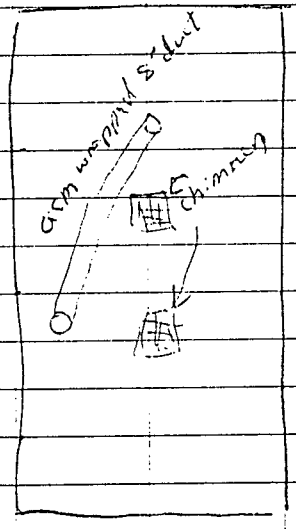
Rm 13A (area above closet
- 10" duct (fiberglass) wrap
- Plaster lath
- white fluffy material
Sample CGA-061 @ 0910, west end
lath plaster
Sample CGA-062 @ 0912, west end
insulated duct, yellow w/ gray vinyl cover
Rm 16 (Stairway landing)
- carpeted
- plaster walls & ceiling
Some cracking, east end
wall/ceiling jct.
(~4 lin. ft.)
- 1 light, 1 smoke detector
- 1 attic access
Sample: CGA-065 plaster,
behind light switch at top of stairs
~~landing~~ (4' off floor) 0955

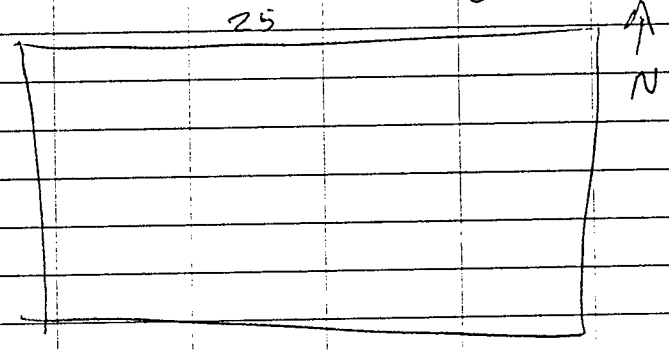
Bldg 996 (Air Drop Building)

1 room
- smooth concrete floor
- no lights, no plumbing
- 2 gable vents
- masonite (5/16") on fiberboard walls

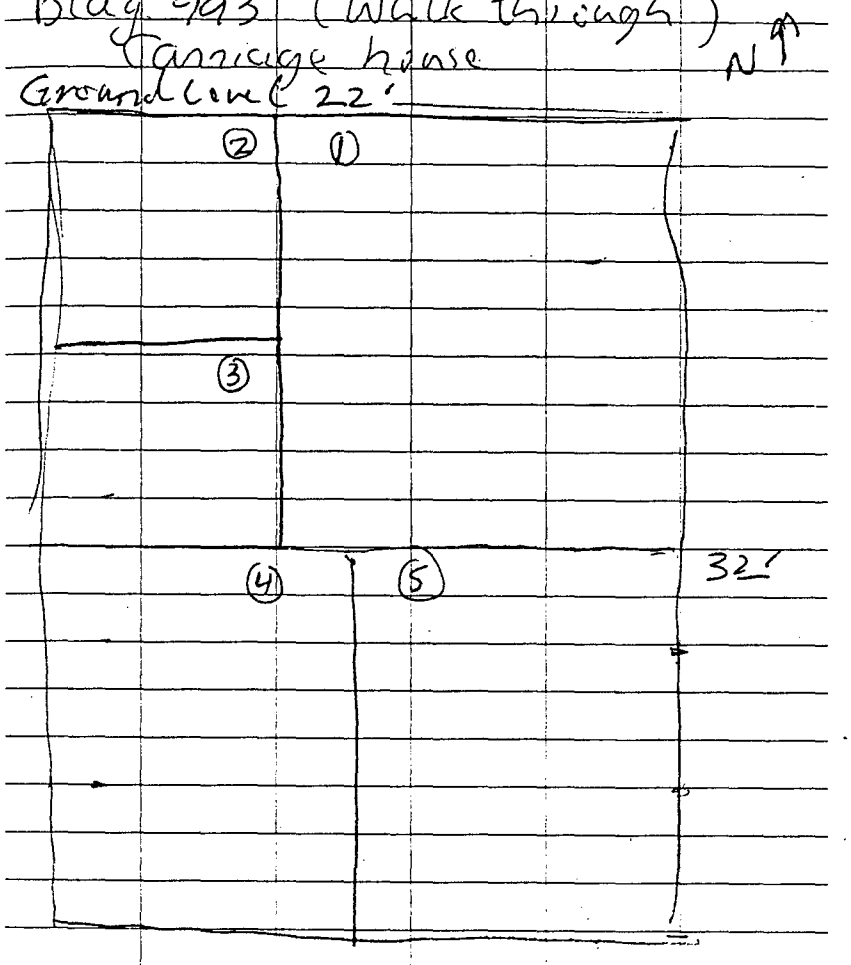
Bldg 993 (walk through)
Carriage house

Rm (1) Shop area
2'x4' pegboard on south & east walls
- wood panel walls & ceiling & wood (painted) flooring

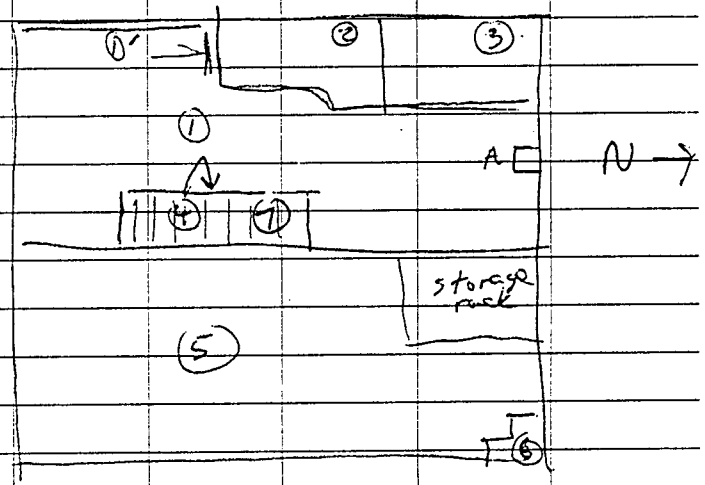
Start at SW corner, ground floor

① Suspect ACM (office/lounge area) sheetrock - southwest corner

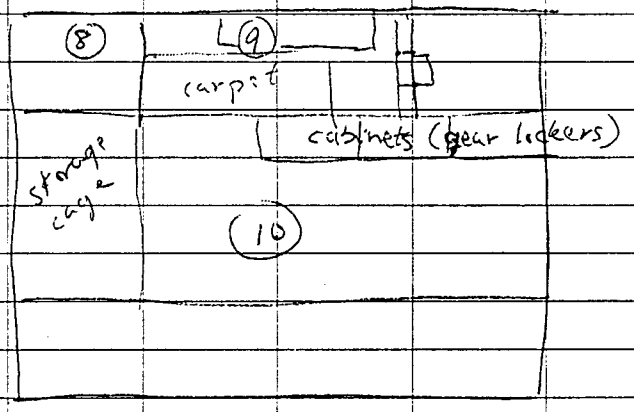
Bldg 995 - 2nd floor

(8) storage area
no acm

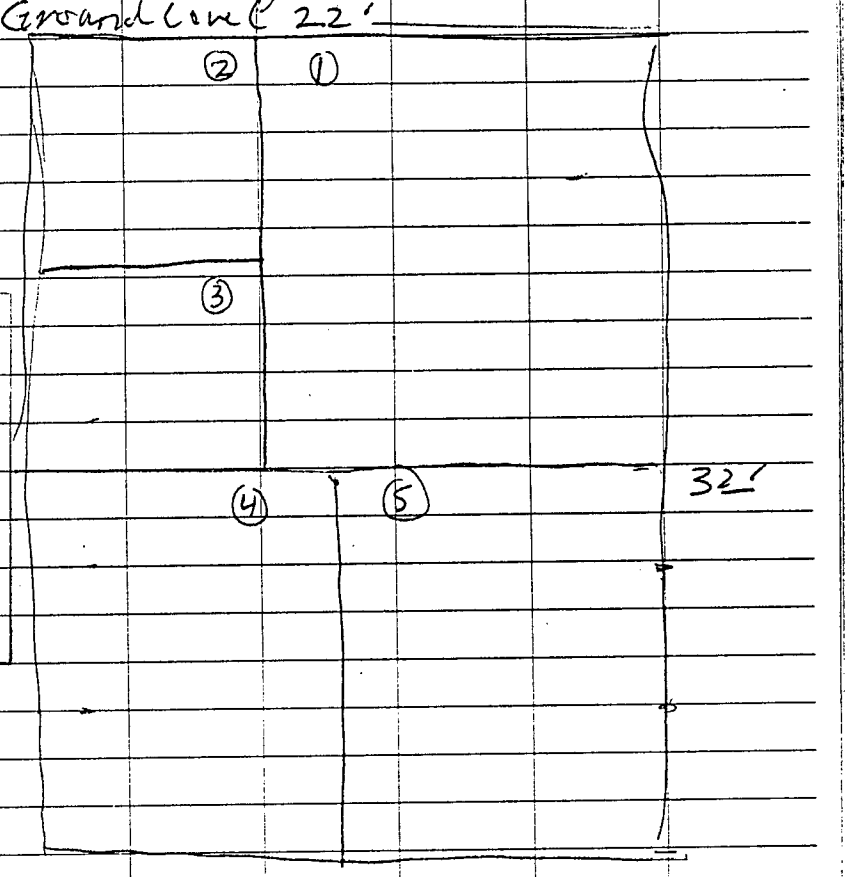
Bldg 993 (walk through)
Carriage house

Rm (1) Shop area
2'x4' pegboard on south & east walls
- wood panel walls & ceiling & wood (painted) flooring

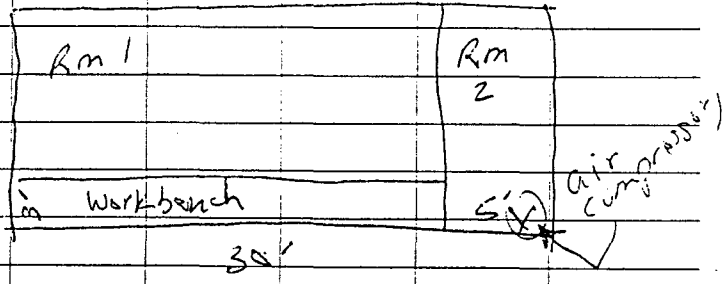
→ Bldg 998 - Point maintenance Shop
Bldg. 998 - built on the pier, ~~floor is the pier~~, wga one level w/ attic storage area, all wood construction w/ asphalt shingles

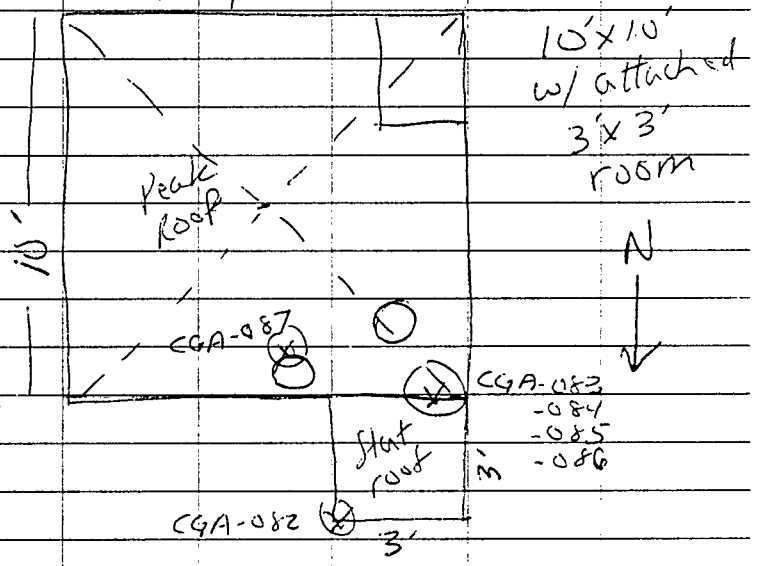
Bldg 999 - Tide Gaging Shack

- All wood construction, wood siding
- interior of 10'x10' room has finished wood lap paneling on walls & ceiling, same for floors

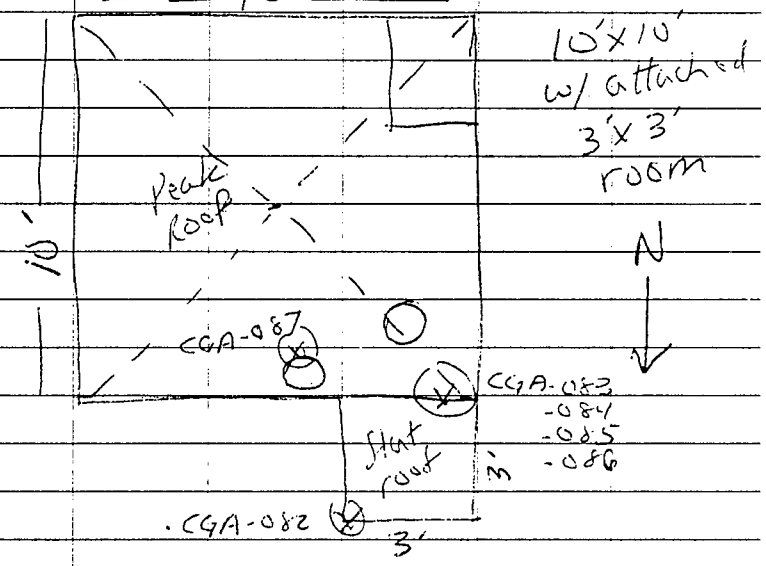
Bldg 999 - Tide Gaging Shack

- All wood construction, wood siding
- interior of 10'x10' room has finished wood lap paneling on walls & ceiling, same for floors
